# NASA Technical Memorandum 58244

## Full-Scale Flammability Test Data for Validation of Aircraft Fire Mathematical Models

Jerome F. Kuminecz and Richard W. Bricker  
*Lyndon B. Johnson Space Center  
Houston, Texas*

February 1982

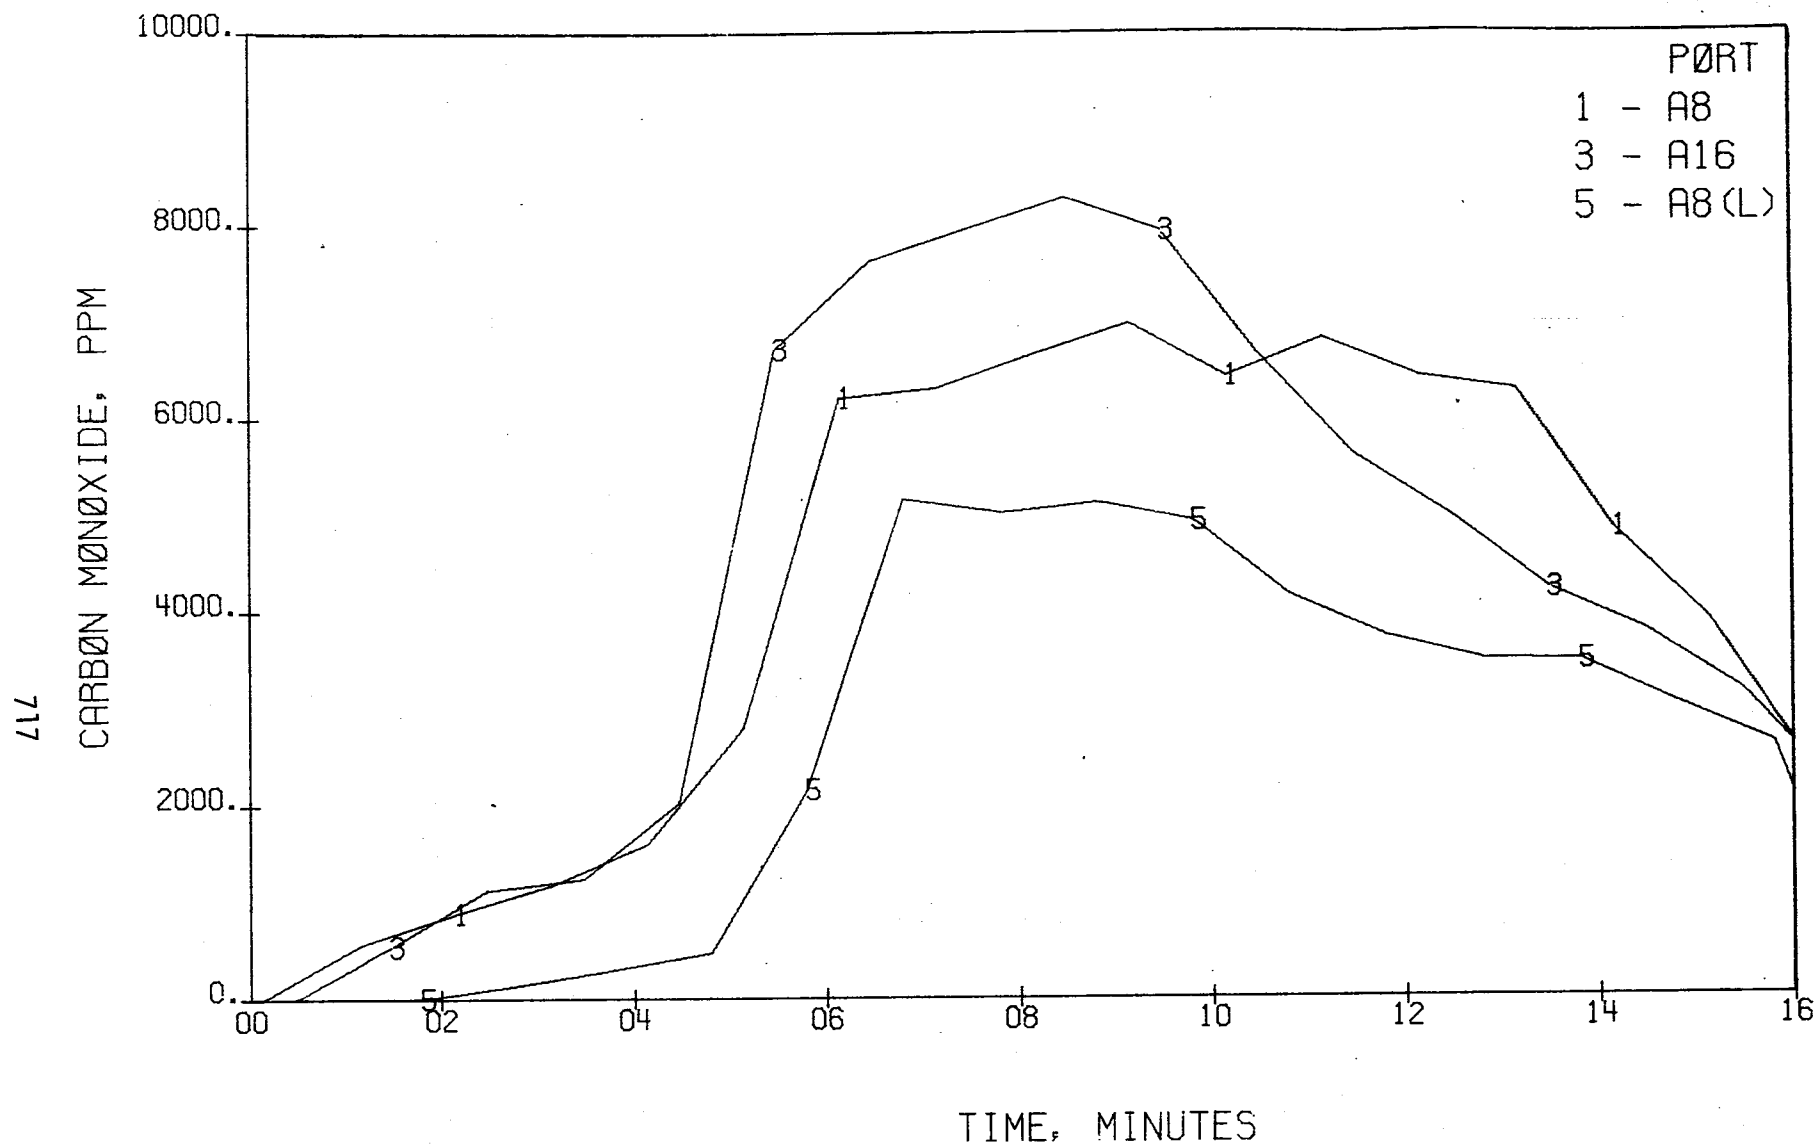
FIGURE 579 . - CARBON MONOXIDE CONCENTRATIONS , AFT  
TEST 24
